Georgian Yacht Club Dock Condition Inspection Report

The Georgian Yacht Club

SHOREPLAN

FINAL
September 2025

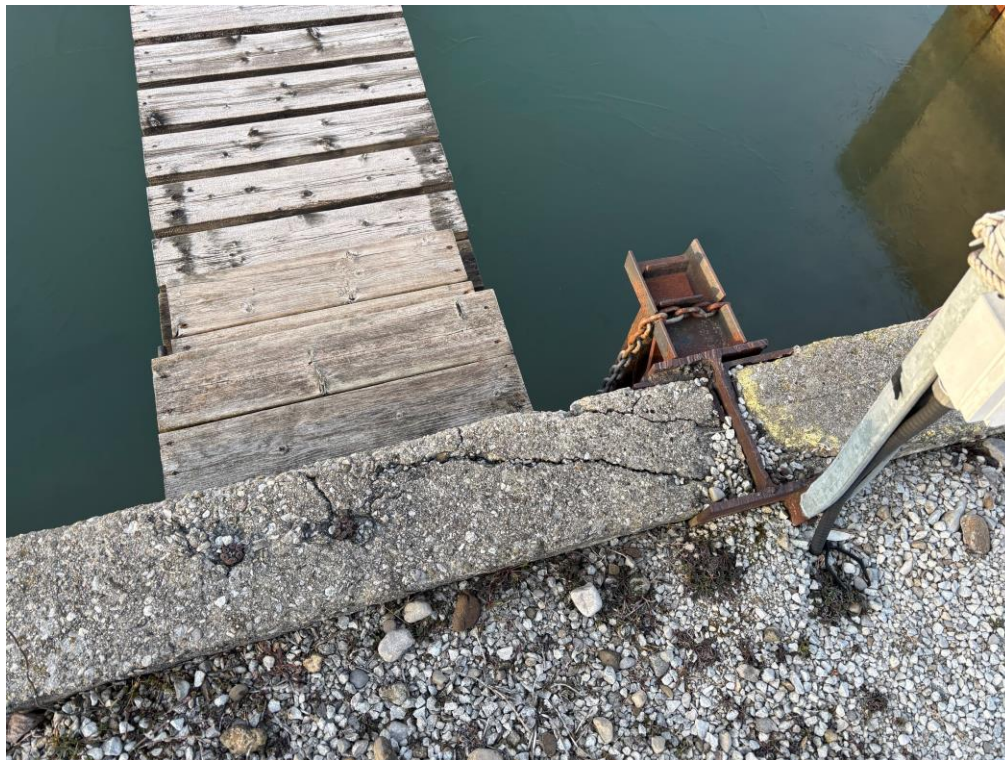
Photo 3.11 Cracking of Concrete Panel at S7 (10/04/2025)

Above water inspections of the walls found that the concrete panels are in poor condition. Numerous diagonal and horizontal cracks can be seen running across the panel. The top face of the concrete is also showing signs of significant deterioration, cracking, and spalling of material. Concrete panels with significant spalling also exposed the rebar inside.

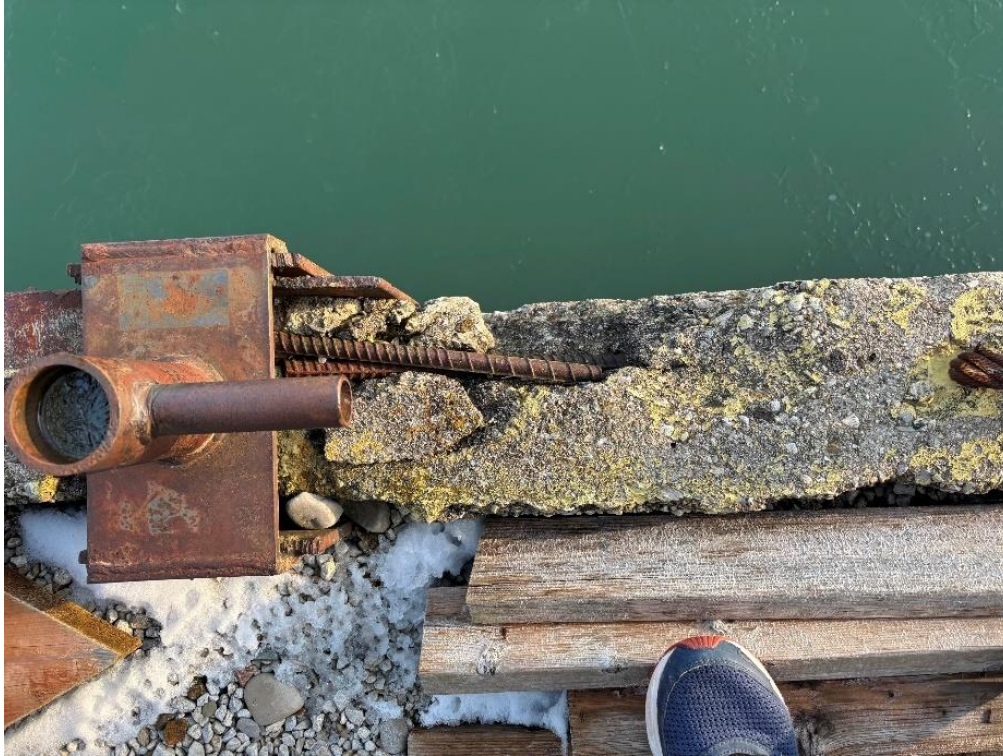
Photo 3.12 Exposed Concrete Panel Rebar at S9 (10/04/2025)

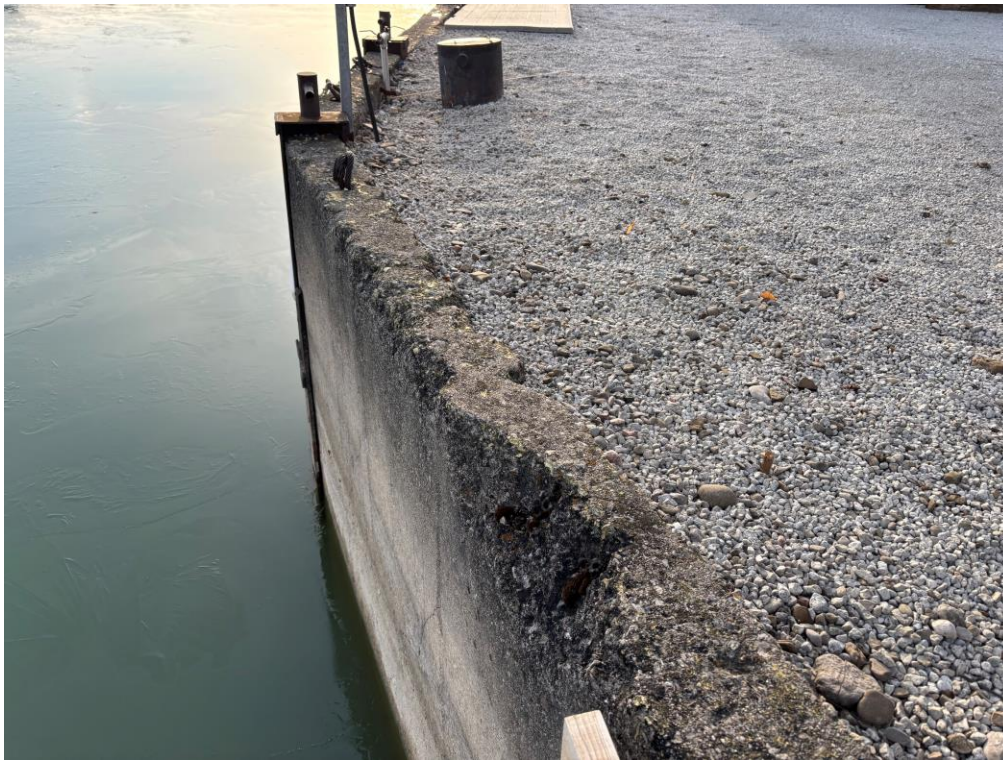
Photo 3.13 Spalling of Concrete Panel at S10 (10/04/2025)

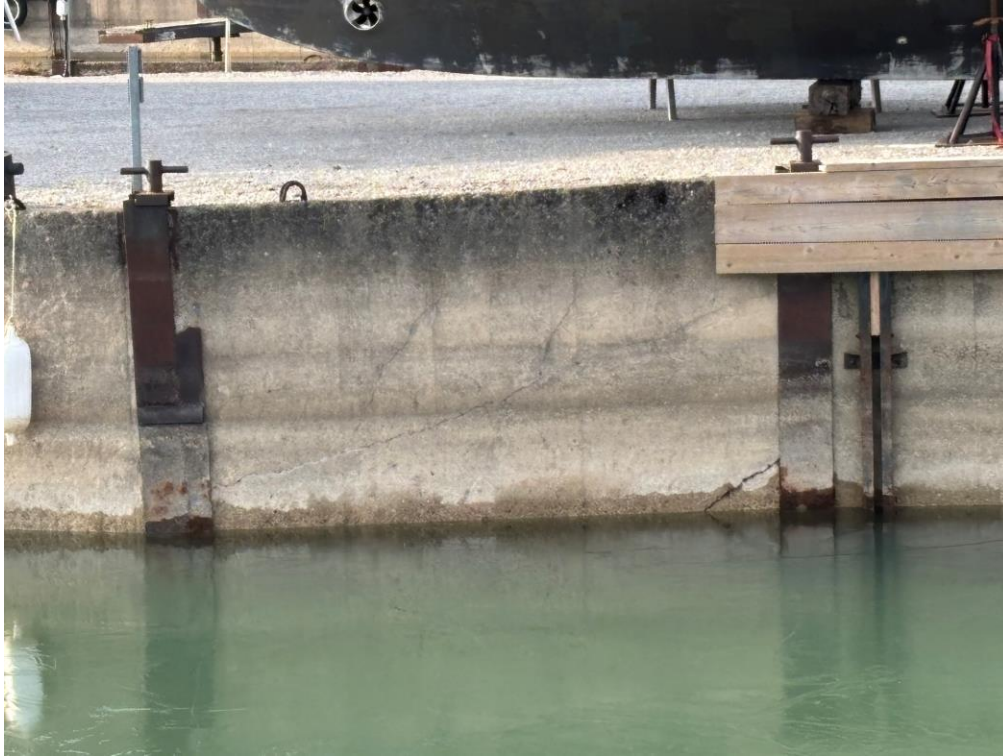
Photo 3.14 Cracking and Tilting of Concrete Panel (10/04/2025)

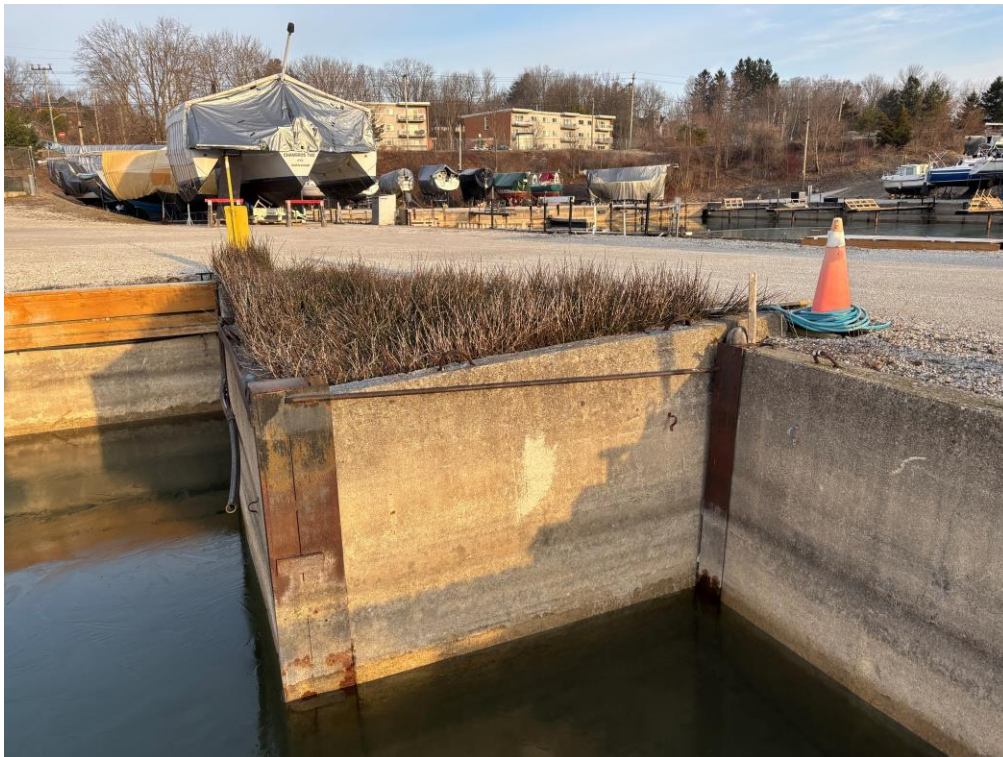
Photo 3.15 Tilted Concrete Panel (10/04/2025)

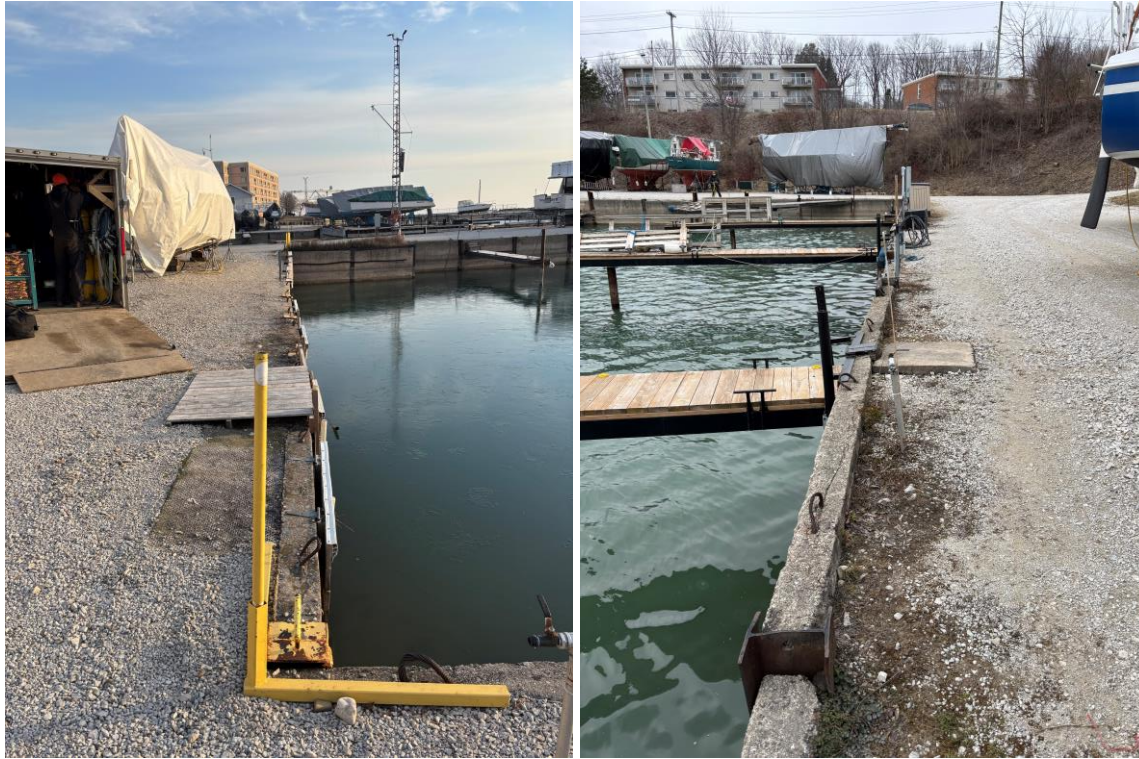
Photo 3.16 Leaning of Basin Walls at S4 (Left) and S13 (Right) (10/04/2025)

The KPs were observed to be in fair condition. No major damage to the pile was observed. The piles had signs of corrosion that are typical of marine environments. Some of the pile flanges have minor deformations, possibly due to blunt impacts from vessels in the basin. The dock wall condition is relatively consistent except for several areas. There are some sections of the dock wall where the KPs and concrete panels appear to lean forward into the basin. The batter measurements taken show that most of the piles are leaning forward by 2-3 degrees. Some sections of the dock wall also had concrete panels that appear to have settled into the lake bottom. Some panels are much lower than the adjacent panels. Some panels are also tilted in between KPs, possibly due to loss of fill or differential settlement. Observations of the backshore behind the concrete panels also show that there may be loss of backfill material through the bottom of the concrete panels. Several locations, such as the southwest corner of the south basin, appear to be sunken. These areas also coincide with locations of the marina with higher lake bottom.

We recommend GYC restrict access along the back of the wall. No live loads (vehicles, boat storage or other concentrated loads) should be located within 3 m of the back of the wall where the walls are constructed with the smaller king piles (W250x49). We also recommend that GYC make plans to replace the KP walls.

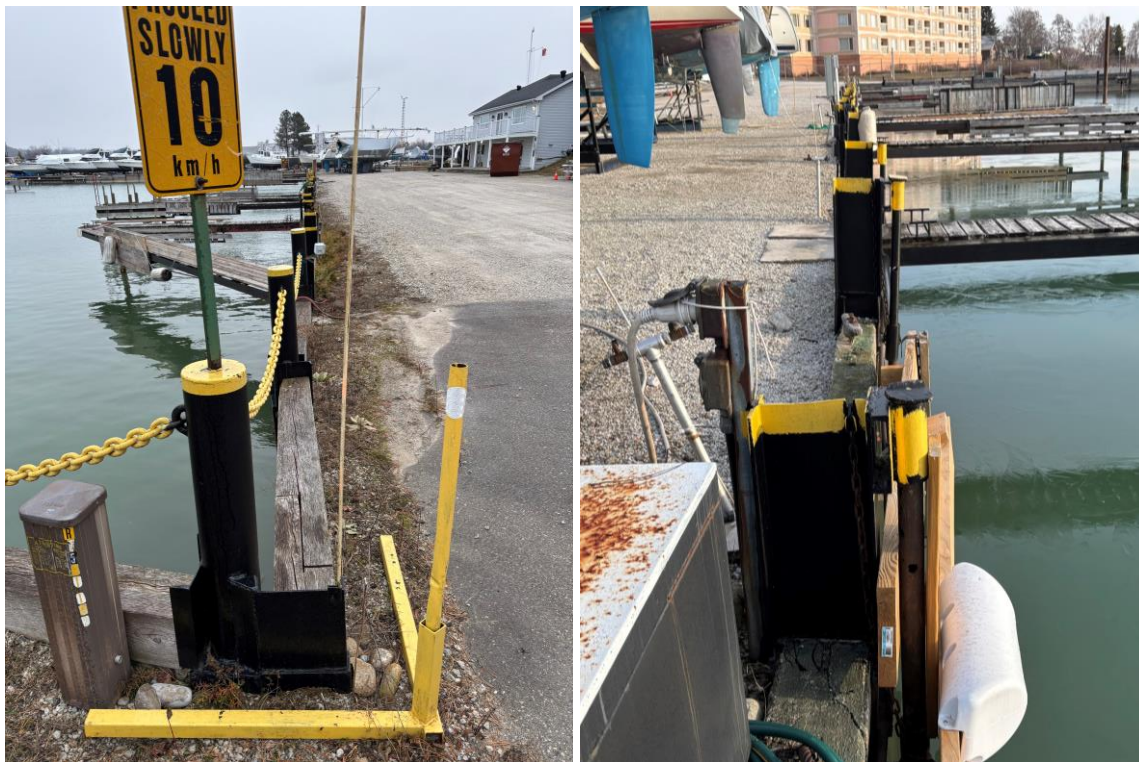
Photo 3.17 Leaning of North Basin Wall at S16 (10/04/2025)

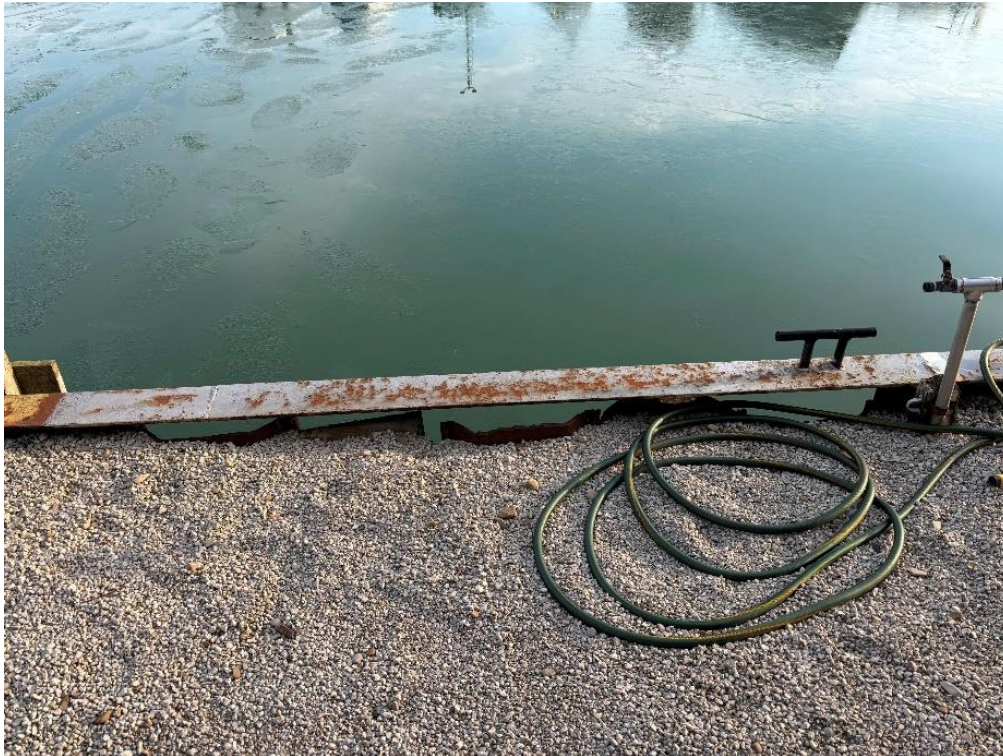
Photo 3.18 Splitting of SSP Knuckles (10/04/2025)

The SSP appears to be in fair condition. Typical rusting of the sheets was observed, but no significant damage was noticed. Separation of the SSP knuckles at the top of the wall was observed on the south entrance area sheets. Weld seams and lifting holes were observed on most of the U-section SSP. It appears that the SSP was not driven with full length sheets and cut down, but rather shorter lengths of sheets were welded together to form longer piles for construction. The L-section sheets appeared to be in better condition than the U-section sheets.

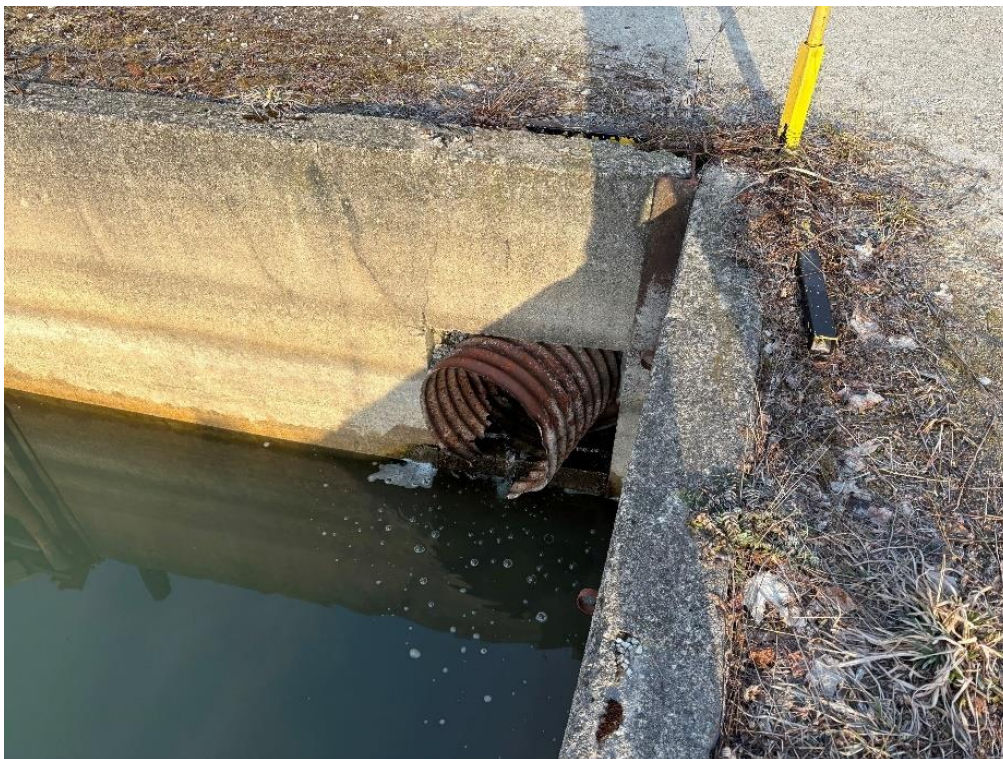
Photo 3.19 Pipe Outlet at S12 (10/04/2025)

Several drain holes and pipe outlets can be found around the marina. A 50 mm diameter drain can be found along S4 at approximately 0+02. A 178 mm diameter drain can be found along S12 at approximately 0+08. A large 600 mm diameter corrugated steel pipe (CSP) can be found along S12 at approximately 0+52. A 165 mm diameter drainpipe can be found along S13 at approximately 0+65.

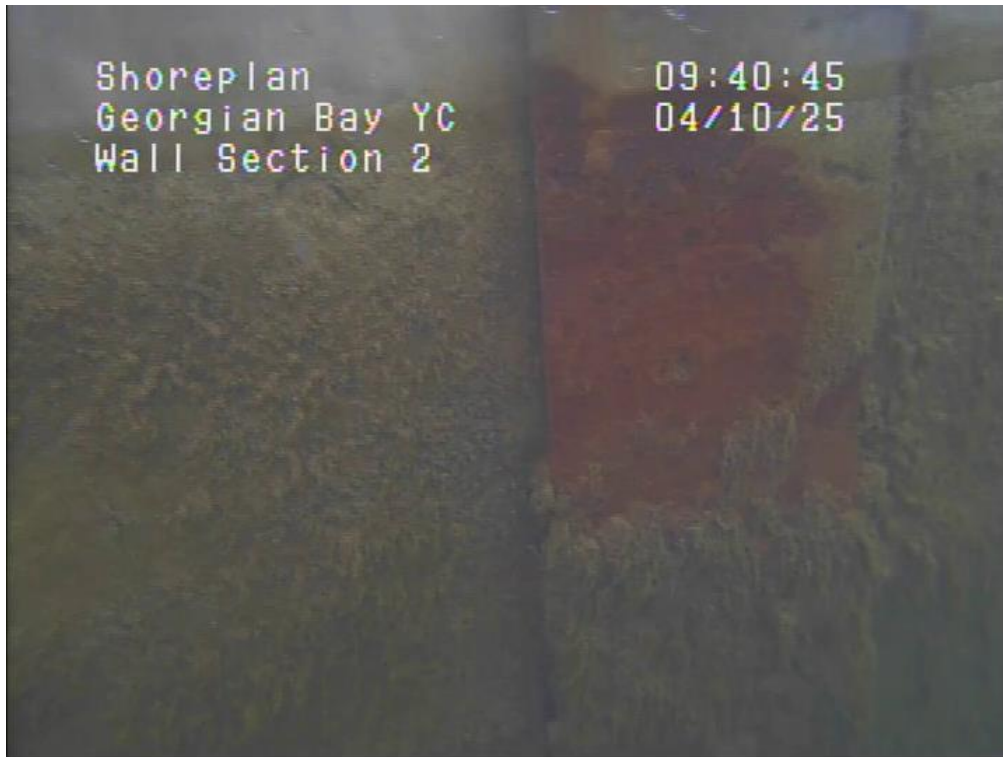
Photo 3.20 Typical Rusting of KP at Water Line (10/04/2025)

The underwater inspection reviewed that the KPs and concrete lagging panels are in poor condition. The diver noted that all piles appeared to have quite consistent signs of rusting, especially at the waterline. The thickness measurements show that corrosion thickness was between 1-4 mm on the flanges of the KPs. The diver noted that many of the concrete panels had severe cracking and/or spalling. All concrete panels had some degree of cracking visible. The diver also noted that some of the panels were not sitting directly on lake bottom. The gap between the lake bottom and the panel ranges from 12.7 mm to 150 mm.

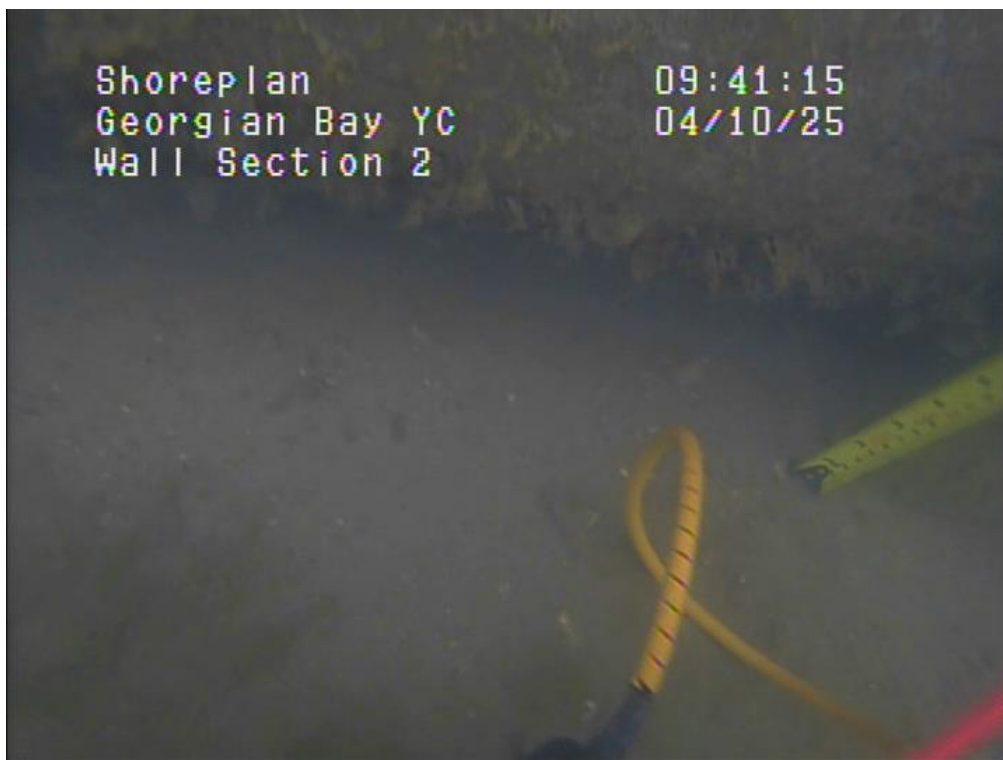
Photo 3.21 Gap Between Concrete Panel and Lake Bottom (10/04/2025)

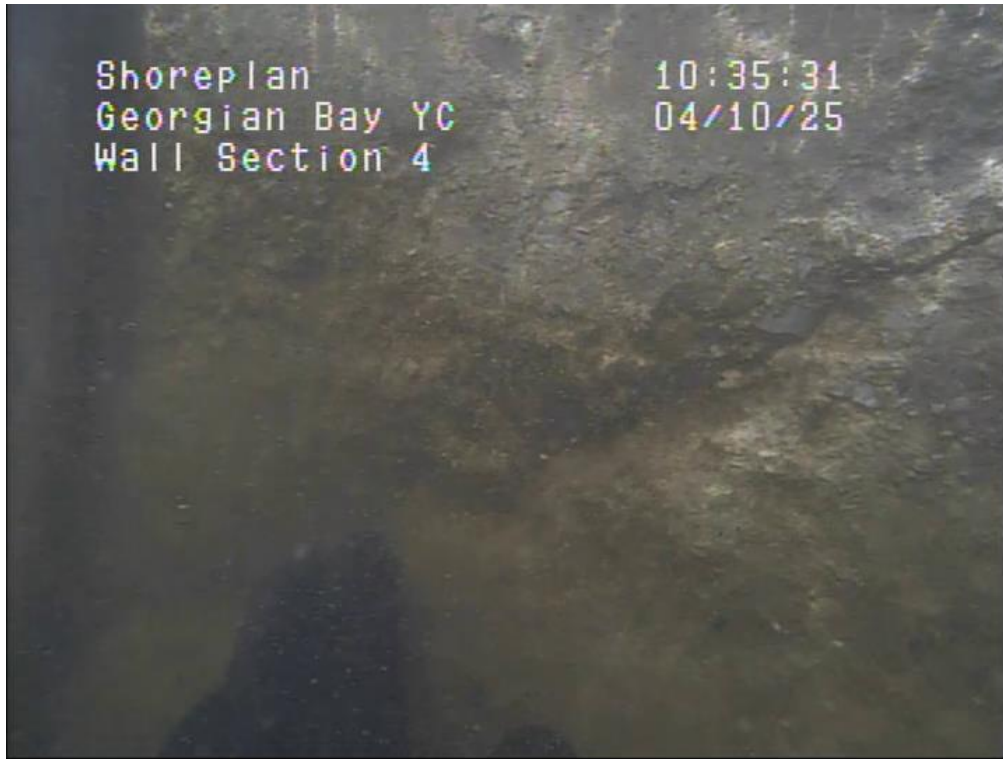
Photo 3.22 Spalling of Concrete Panel (10/04/2025)

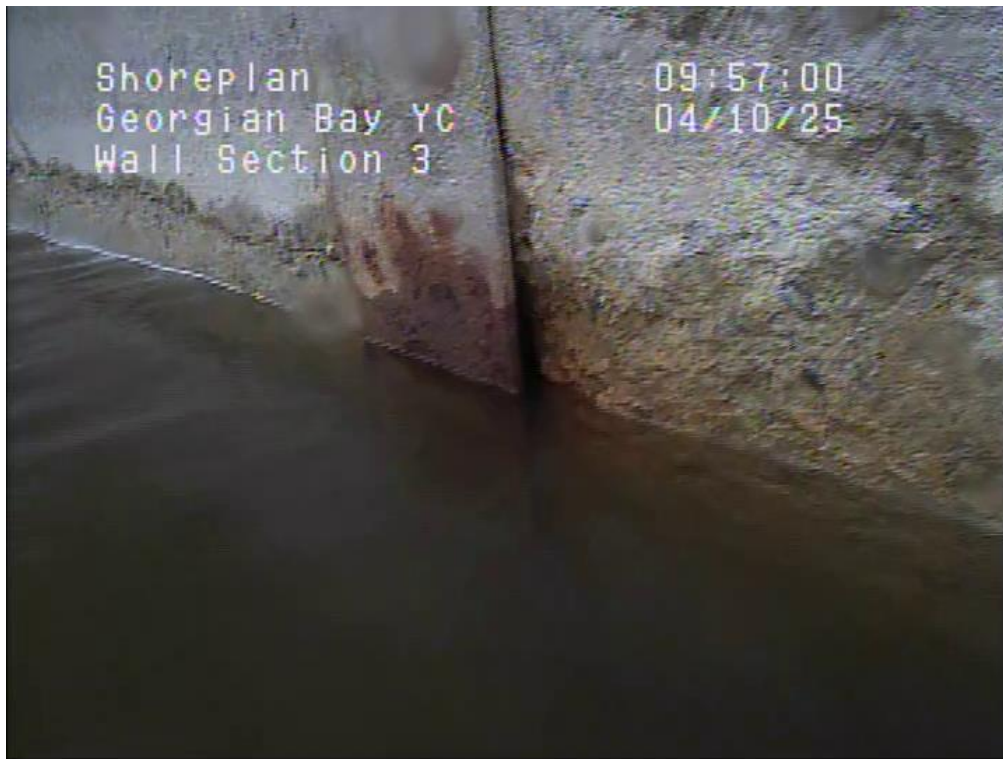
Photo 3.23 Cracking of Concrete Panel (10/04/2025)

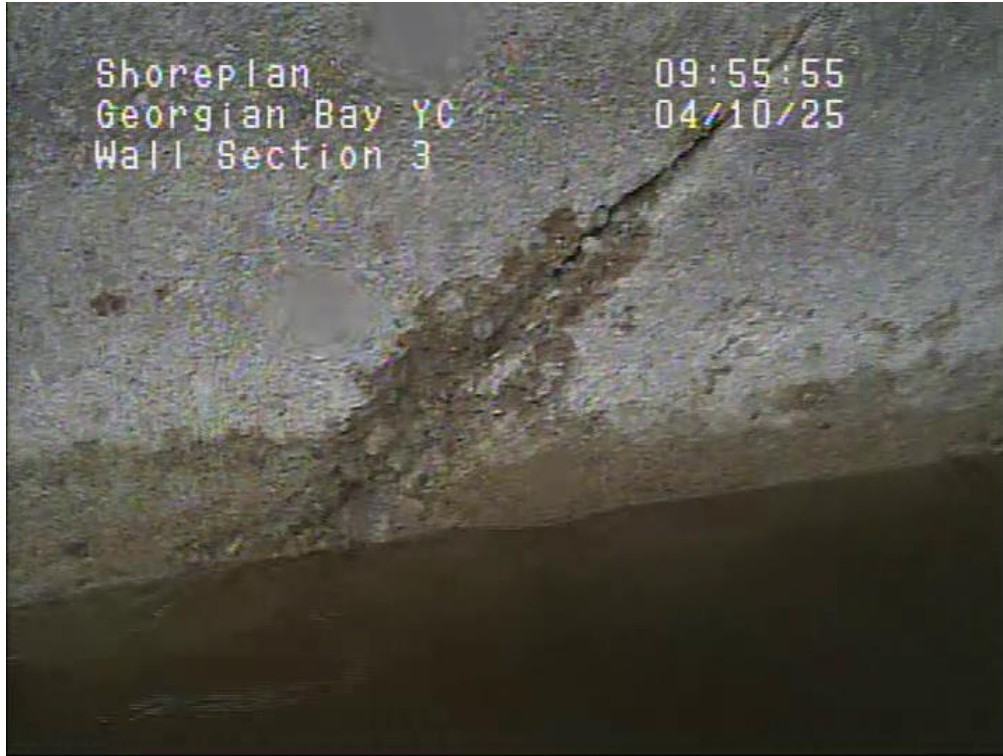
Photo 3.24 Cracking of Concrete Panel (10/04/2025)

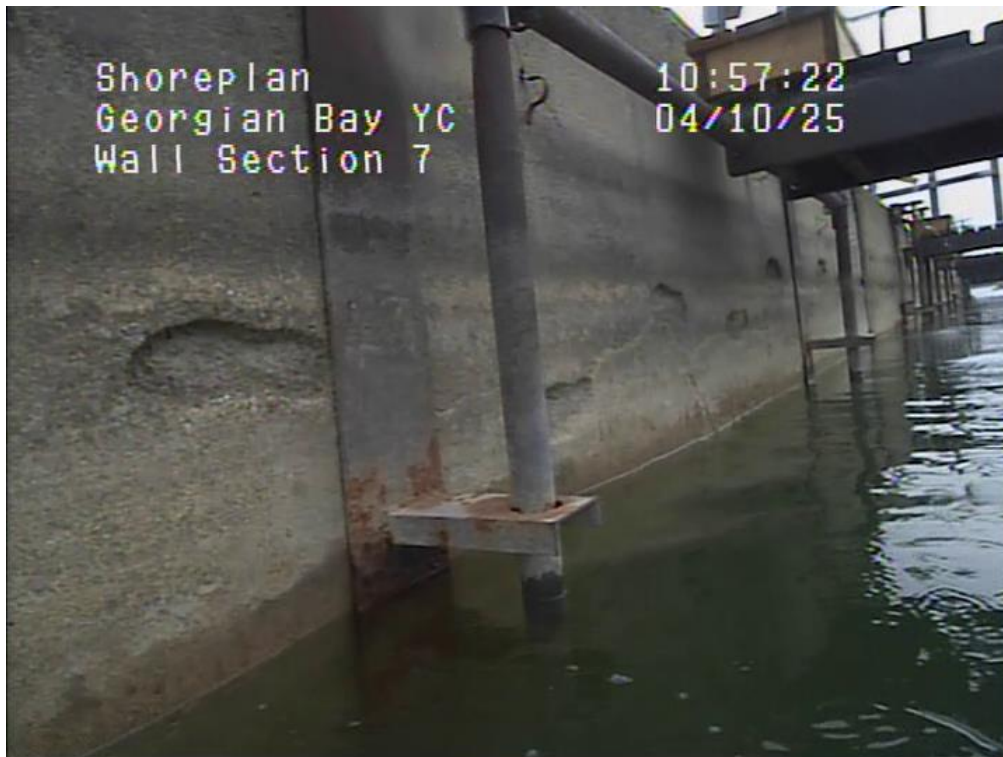
Photo 3.25 Footprints in Concrete Panel at S7 (10/04/2025)

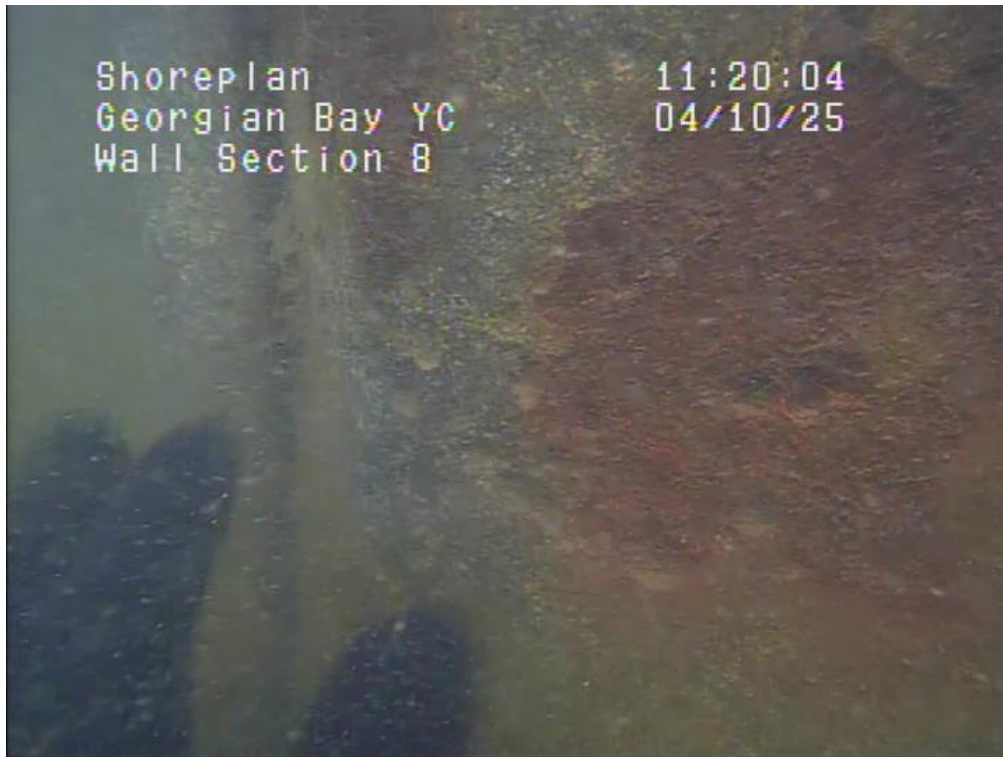
Photo 3.26 Rusting and Pitting of SSP (10/04/2025)

Based on the underwater inspection, the SSP around the south basin and entrance area appears to be in fair condition. Similar to the KPs, the diver noted that the SSP has signs of corrosion mainly around the waterline. The thickness measurements show that the corrosion on the sheet piles are between 1-4 mm. The SSP at S15 appeared to be in much better condition. The thickness measurements taken at waterline at this location appeared to be thicker than the SSP at the top of the pile.

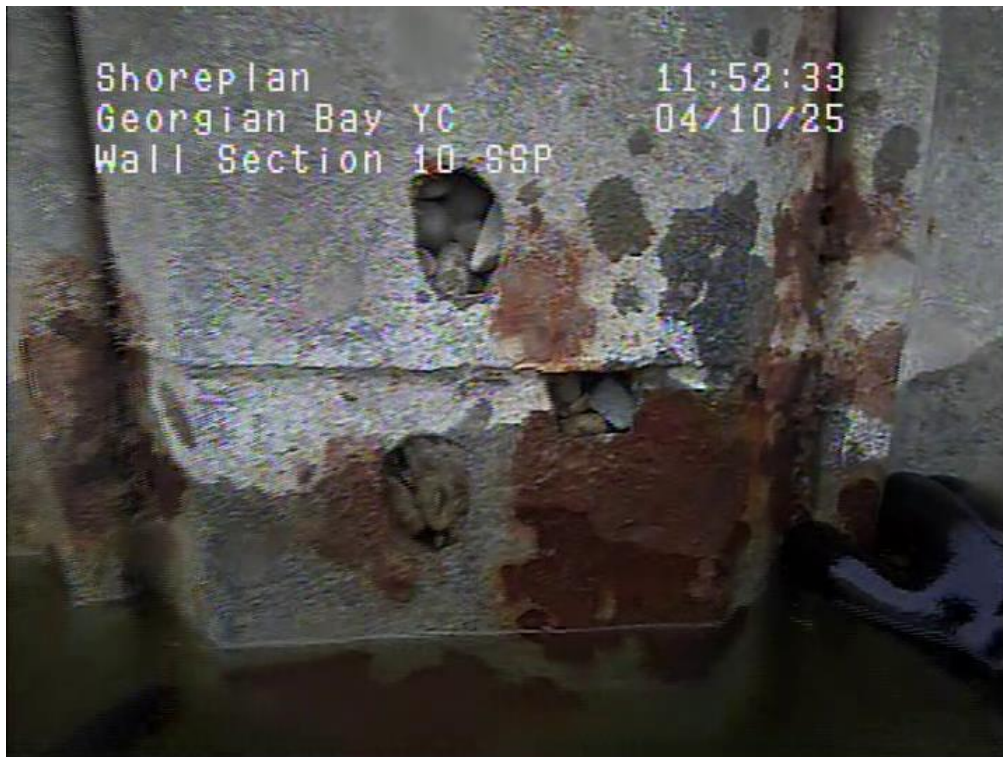
Photo 3.27 Weld Seam and Lift Holes in SSP (10/04/2025)

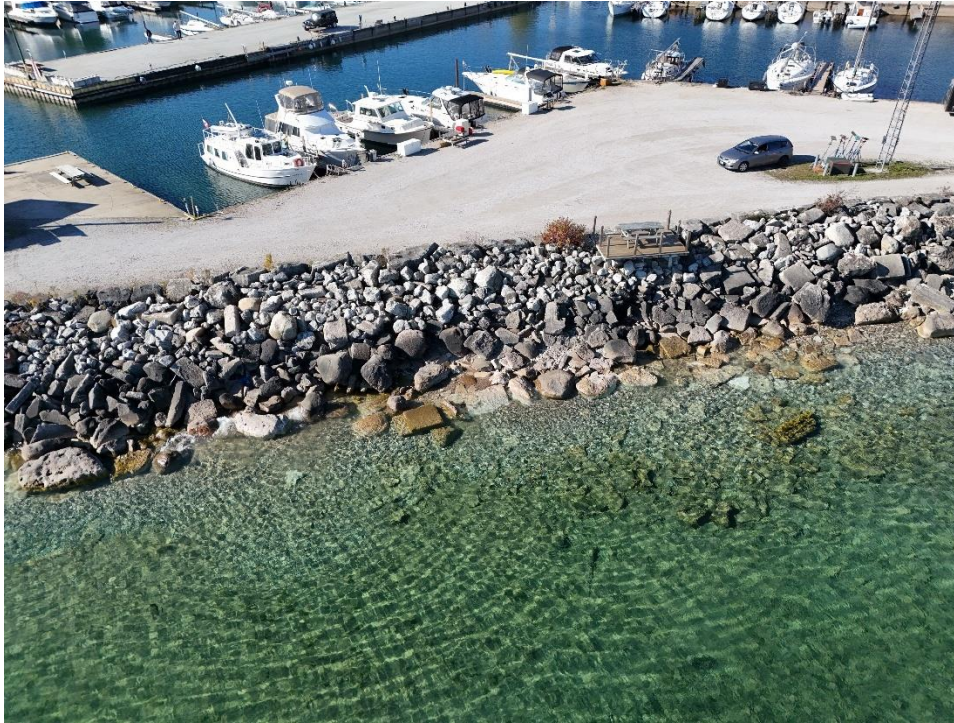
Photo 4.1 View of North Berm (2024 10 18)

Overall, the rock structure is in fair to good condition. It appears to be functioning adequately with some areas requiring addition stone along the north side of the entrance breakwater. No signs of wave damage were noted along the back side of the structure during the site visit. The structure would benefit from addition stone in the steeper areas.

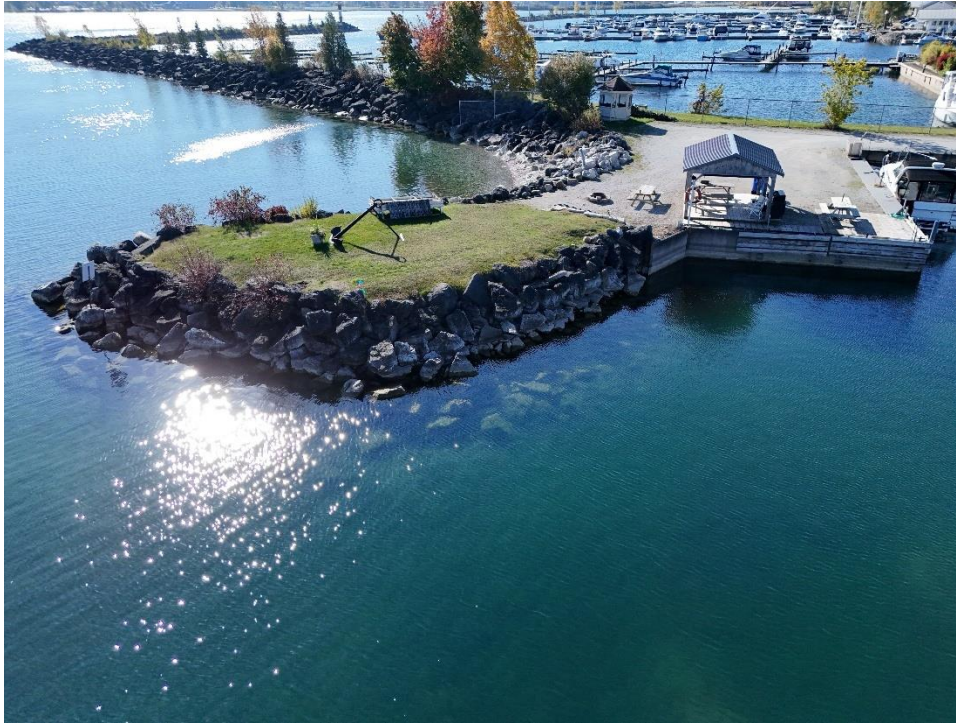
Photo 4.4 View of South Breakwater (2024 10 18)

Overall, the rock structure is in good condition except the north face at the entrance which is in fair condition. It appears to be functioning adequately with no signs of wave damage were noted along the back side of the structure during the site visit. Some low spots were noted along the back of the structure most likely due to loss of fill material between gaps in the stone. The structure would benefit from addition stone in the steeper area.
